# **Space Shuttle Independent Assessment Team**

Report to Associate Administrator  
Office of Space Flight

October - December 1999

March 7, 2000

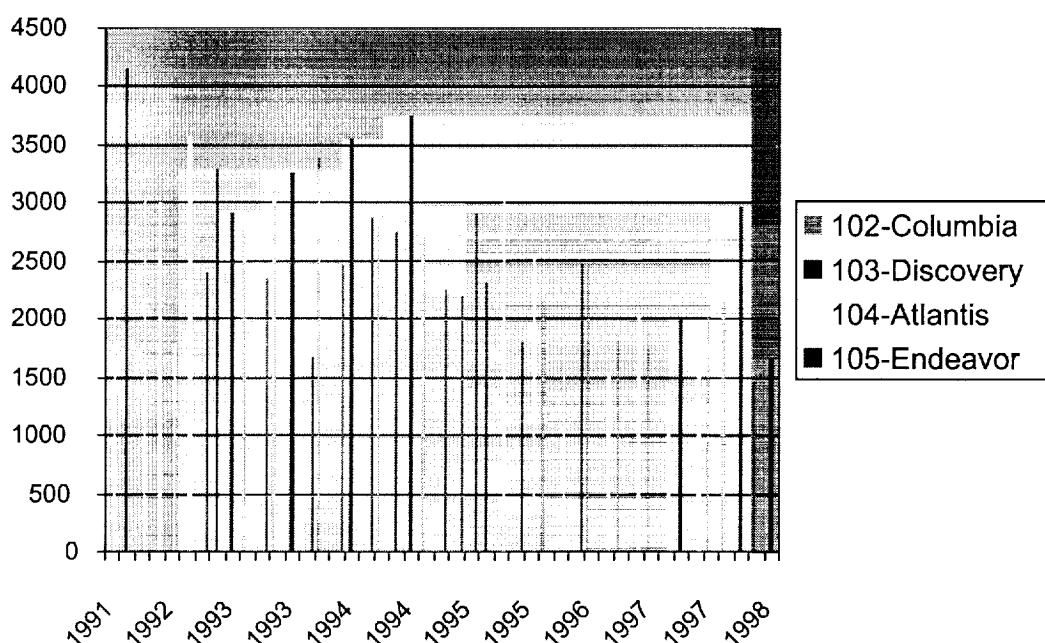
Figure 4 -- Problem Reports by Orbiter

Report count, it is clear from the data shown in *Figure 4 -- Problem Reports by Orbiter* that there is a decline in the average number of Problem Reports after 1995. This decline may reflect changes in reporting requirements, such as the increase in allowable discrepancies due to Fair, Wear and Tear, and improvements in process or hardware. However, the decline may also reflect the reduction in Government Mandatory Inspection Reports, quality assurance personnel ("second set of eyes"), and/or other checks and balances on the system. This finding is corroborated by the audit (draft) of the Marshall Space Flight Center Problem Resolution and Corrective Action system by Safety & Mission Assurance personnel: "Recent numbers of problems being reported by the contractors into the Marshall Space Flight Center Problem Resolution and Corrective Action system ... are down...." The report went on to state the concern that "these reductions do not seem to be completely justified by test schedules, revision from in-family screening and similar requirements adjustments, or improved hardware." The decline in Problem Report reports requires deeper investigation to ascertain its true cause and acceptability.

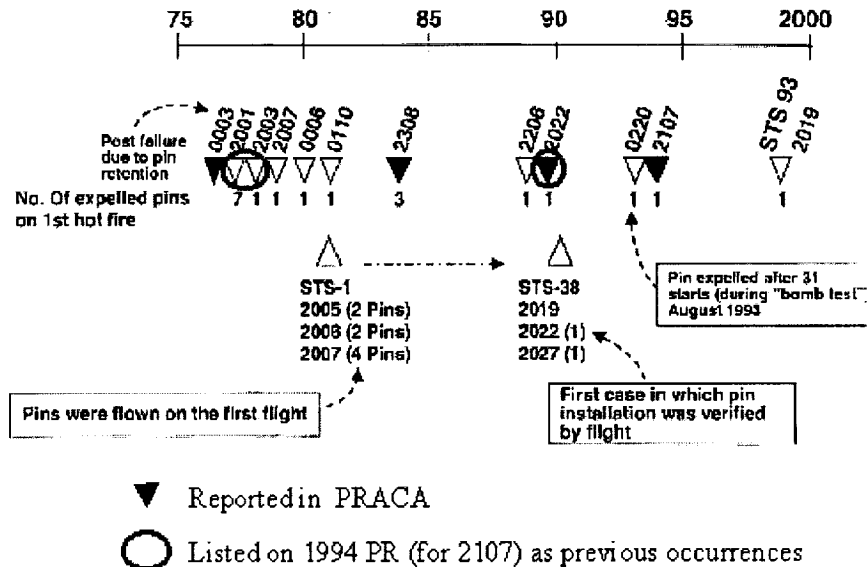
Figure 5 -- Problem Tracking Example: SSME Liquid Oxygen Post Pins

A second quantitative assessment of the data in the Problem Resolution and Corrective Action system was made by tracking a known problem, namely that of the Main Injector liquid oxygen pin ejection. Both the Marshall Space Flight Center Problem Resolution and Corrective Action system and the data warehouse ADAM were searched for Problem Reports addressing pins in the Space Shuttle Main Engine. Only three of the ten known occurrences of Main Injector liquid oxygen pin ejection were recorded in either system. As shown in *Figure 5 -- Problem Tracking Example: SSME Liquid Oxygen Post Pins*, which is the Rocketdyne-Boeing analysis of the pin ejection history, only occurrences on engines 2308 in 1984, 2022 in 1990, and 2107 in 1994 were reported in the Problem Resolution and Corrective Action system. In contrast, the historical record provided by Rocketdyne-Boeing for problem close-out on the Problem Report for the 1994 occurrence listed a different set of three occurrences: two that occurred before 1980 and the occurrence on engine 2022 in 1990. Further examination of the Problem Report records for Main Injector liquid oxygen pin ejection indicated that the CRIT levels assigned to the functionality and the hardware associated with pin ejection varied from 3/\_, 3/1, to 1/1. Also varying in degree and fidelity was the resolution description provided on each Problem Report.

It is clear from the results of this test of the Problem Resolution and Corrective Action system that the data concerning the occurrence of pin ejection was both incomplete and inconsistent. Confusion concerning the reportability of the problem of pin ejection was still evident during discussions held with engineers as part of this assessment. Pinning of the liquid oxygen post was clearly considered a standard repair and pin ejection understood to be a benign condition. So although the criticality of the hardware (CRIT 1) and the timing of the ejection (during first hot-fire after pinning) require the occurrence to be reported in the Problem Resolution and Corrective Action system, problem reports concerning pin ejection were not always made. Had they consistently been reported, the 1 in 10 probability of occurrence may have raised concern over flying a pinned post on STS-93 without prior hot-firing.

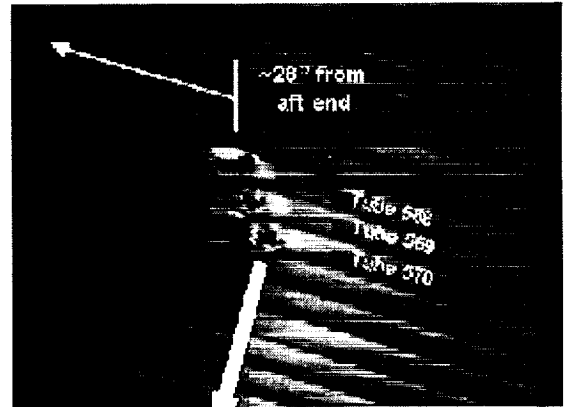
Figure 11 -- Ruptured Tubes, b

Dents noted at all  
3 tube ruptures.  
Evidence of gold present.

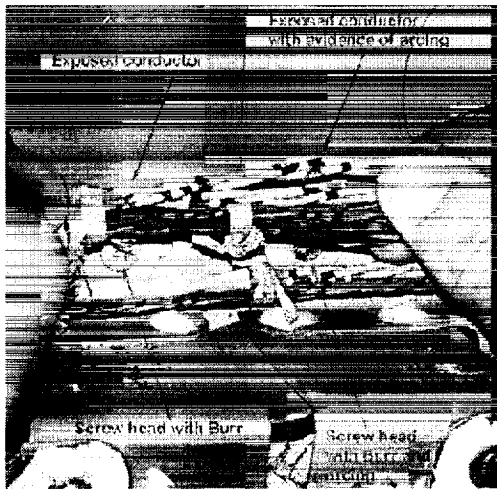
Figure 17 -- Shorted Wire in OV102: Arc Damage & Mechanical Damage

The SIAT was briefed on an in-flight anomaly wiring failure that occurred during the STS-93 mission of OV102 Columbia. Five seconds after the STS-93 launch, a primary and back-up main engine controller on separate engines dropped offline. Controllers were automatically dropped off line when a power fluctuation was detected. This left single engine controllers on two of the three engines (each main Shuttle engine has double redundant controllers). The mission continued uneventfully and after the mission, inspection revealed a single 14 ga. polyimide wire had arced to a burred screw head (*Figure 17* and *Figure 18*). The wire was located in the aft left-hand mid-body bay #11 lower wire tray. A single three amp circuit breaker had tripped, with no electrical damage to adjacent wiring. The wire provided 115 VAC power to each of the controllers that were dropped off line.

Technicians noted a 10 ohm short between the wire electrical ground through the structure of the vehicle. Inspection of the wires in the adjacent area revealed insulation and conductor damage at the short location (*Figure 18*). An expanded inspection of all mid-body wires revealed varying degrees and types of wire insulation damage. All four vehicles exhibited extensive and varying degrees of wire insulation damage from exposed conductors to minor abrasion (*Figure 19*, *Figure 20*, and *Figure 21*). The SIAT was briefed on the Shuttle program analysis of the in-flight anomaly, the results of inspection and repair of wiring on all vehicles, and corrective actions taken to mitigate future wiring failures. In the course of the SIAT's fact-finding process, we reviewed maintenance practices and representative vehicles at the Kennedy Space Center Shuttle processing facility and the Palmdale Shuttle depot facility.

The following is an assessment of the wire incident or mishap based on presentations given by NASA and on NASA laboratory data. The material transfer and welding present provide evidence of arcing; gouges in the conductor were also noted. Surface analysis revealed oxides in the wire strand gouge sites that suggest the damage might have occurred several years earlier. The wiring in the mid-body payload bay is normally covered and records did not indicate the cover had been removed since the last Orbiter Maintenance Down Period (OMDP) that occurred four years earlier at the Palmdale depot facility. Secondary damage caused by the arcing has destroyed most of the insulation and wire damage that was present before the arcing began at the primary failure site. Circumstantial evidence surrounding the failure suggests the wire may have initially been damaged by an impact and subsequent chafing/vibration may have led to the electrical failure. There was no evidence of arc propagation into adjacent wiring.

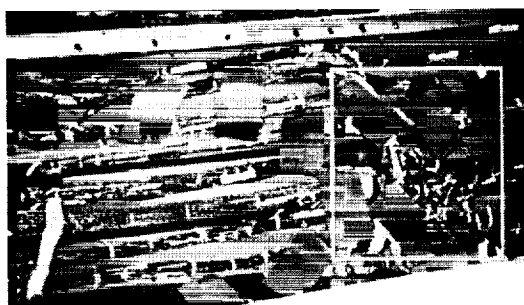
Figure 20 -- Close-up OV103 Mid-Body: Compromised Redundancies, Possible Chafing

According to an early 1990's NASA study, the redundancy in 318 CRIT 1 circuits were compromised by placing the redundant circuits in the same wire bundle or clamp. There were 129 CRIT 1/1 areas identified that violate system separation requirements. NASA Standard 8080 requires that critical circuits be physically separated. As an example, six separate areas exist that, if compromised electrically, would result in the loss of all main engine controllers. A review of the data indicates only violations that could be eliminated required a waiver. At the time of this report, a review of CRIT 2 systems with respect to comprising redundancy was pending.

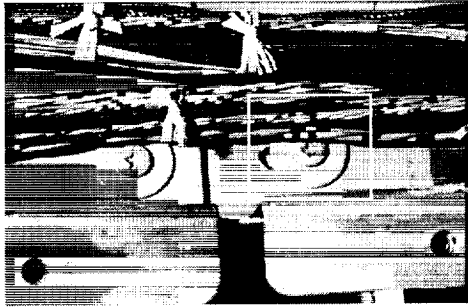
Figure 27 -- Potential Chafe in Mid-Body

It is apparent the current wire tray design contributed to STS-93 wiring failures. The use of a wire tray allows wiring to touch metal surfaces, which has resulted in the wiring contacting screw heads and other sharp surfaces. A past and possibly current maintenance practice has changed tray design assumptions. The reuse of tray screws and an occurrence of burred screw heads have created an unexpected chaffing source (*Figure 28*). There was also considerable configuration variability between vehicles. In some cases additional chafe protection was added or screw heads were covered with a protective coating. The wire bundles were permitted to move in clamps and the trays. Typically, critical circuits must be kept physically separated from all surfaces and other wiring.
